Site Characterization and Geophysical Estimates of Waste Rock and Tailings, Black Mountain Open Space Preserve, San Diego, California

Matthew E. Rochelle
Eric Cathcart, Environmental & Ocean Sciences

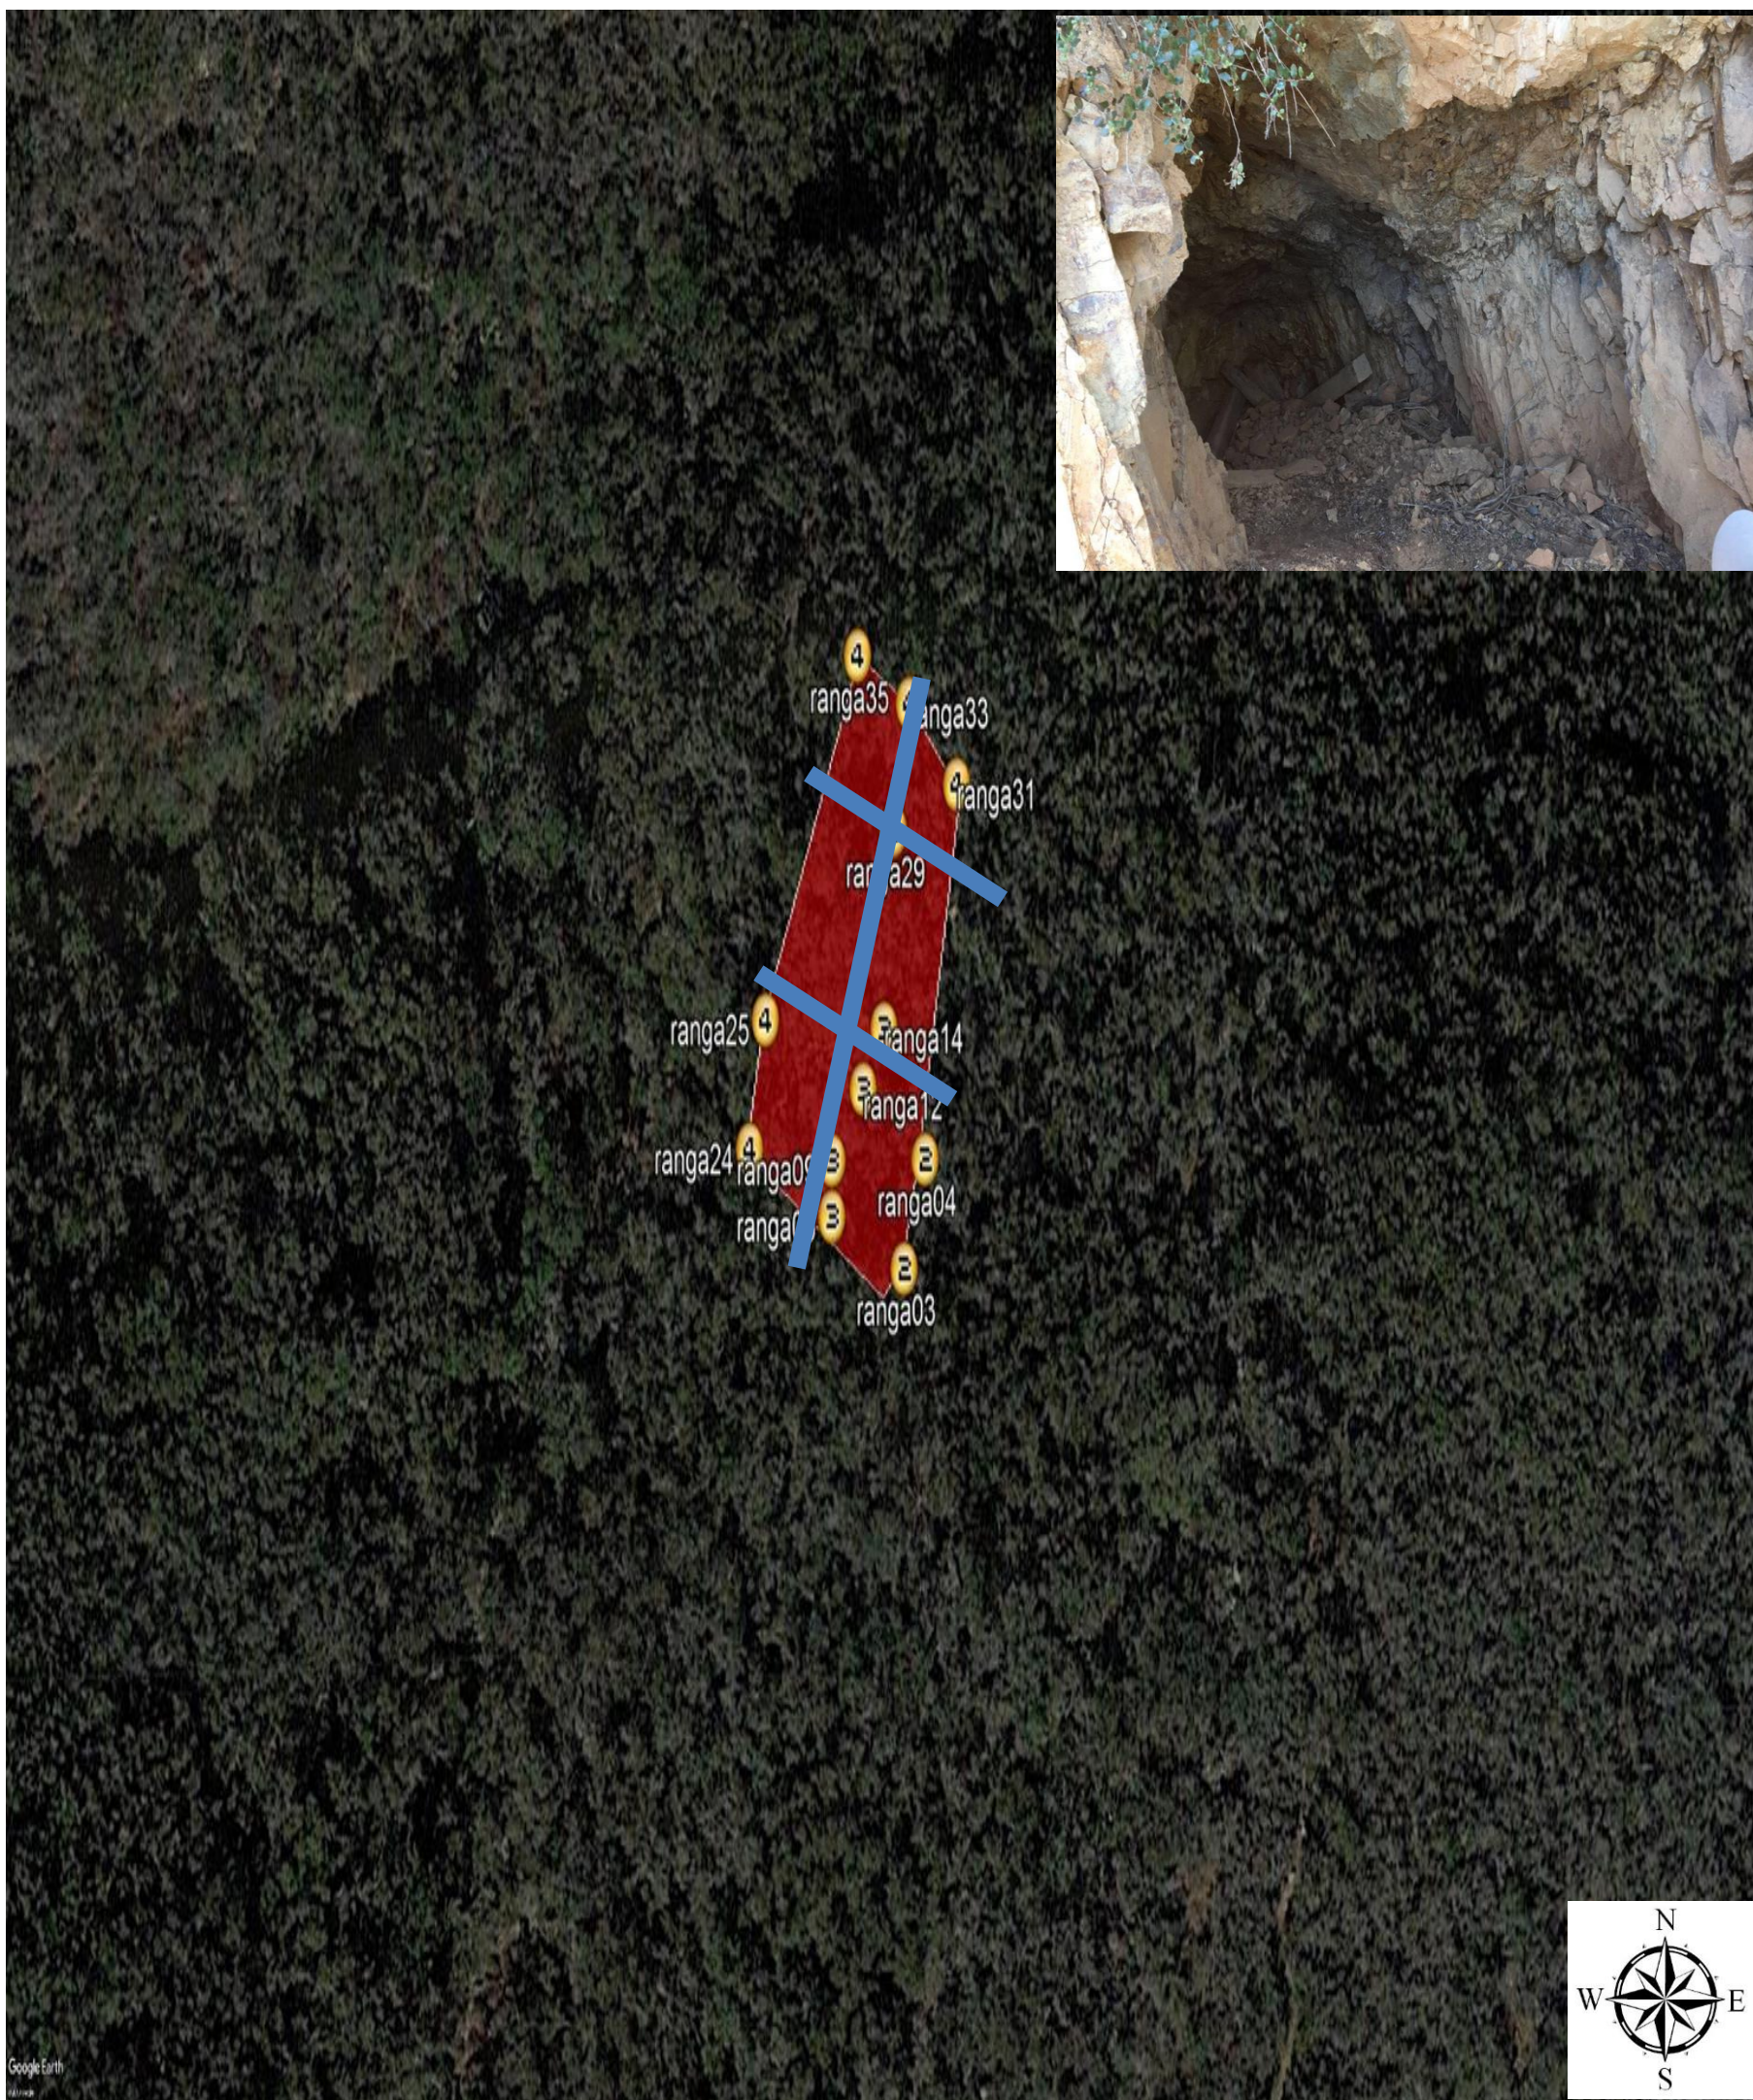
Figure 3: Waste rock surface area and GPS shots for the Ranga shaft. Inset is picture of Ranga mine. Proposed seismic transects in blue.

- In order to obtain a more accurate estimate of the thickness of fill material, a seismic survey will be performed at multiple transects across the canyon.

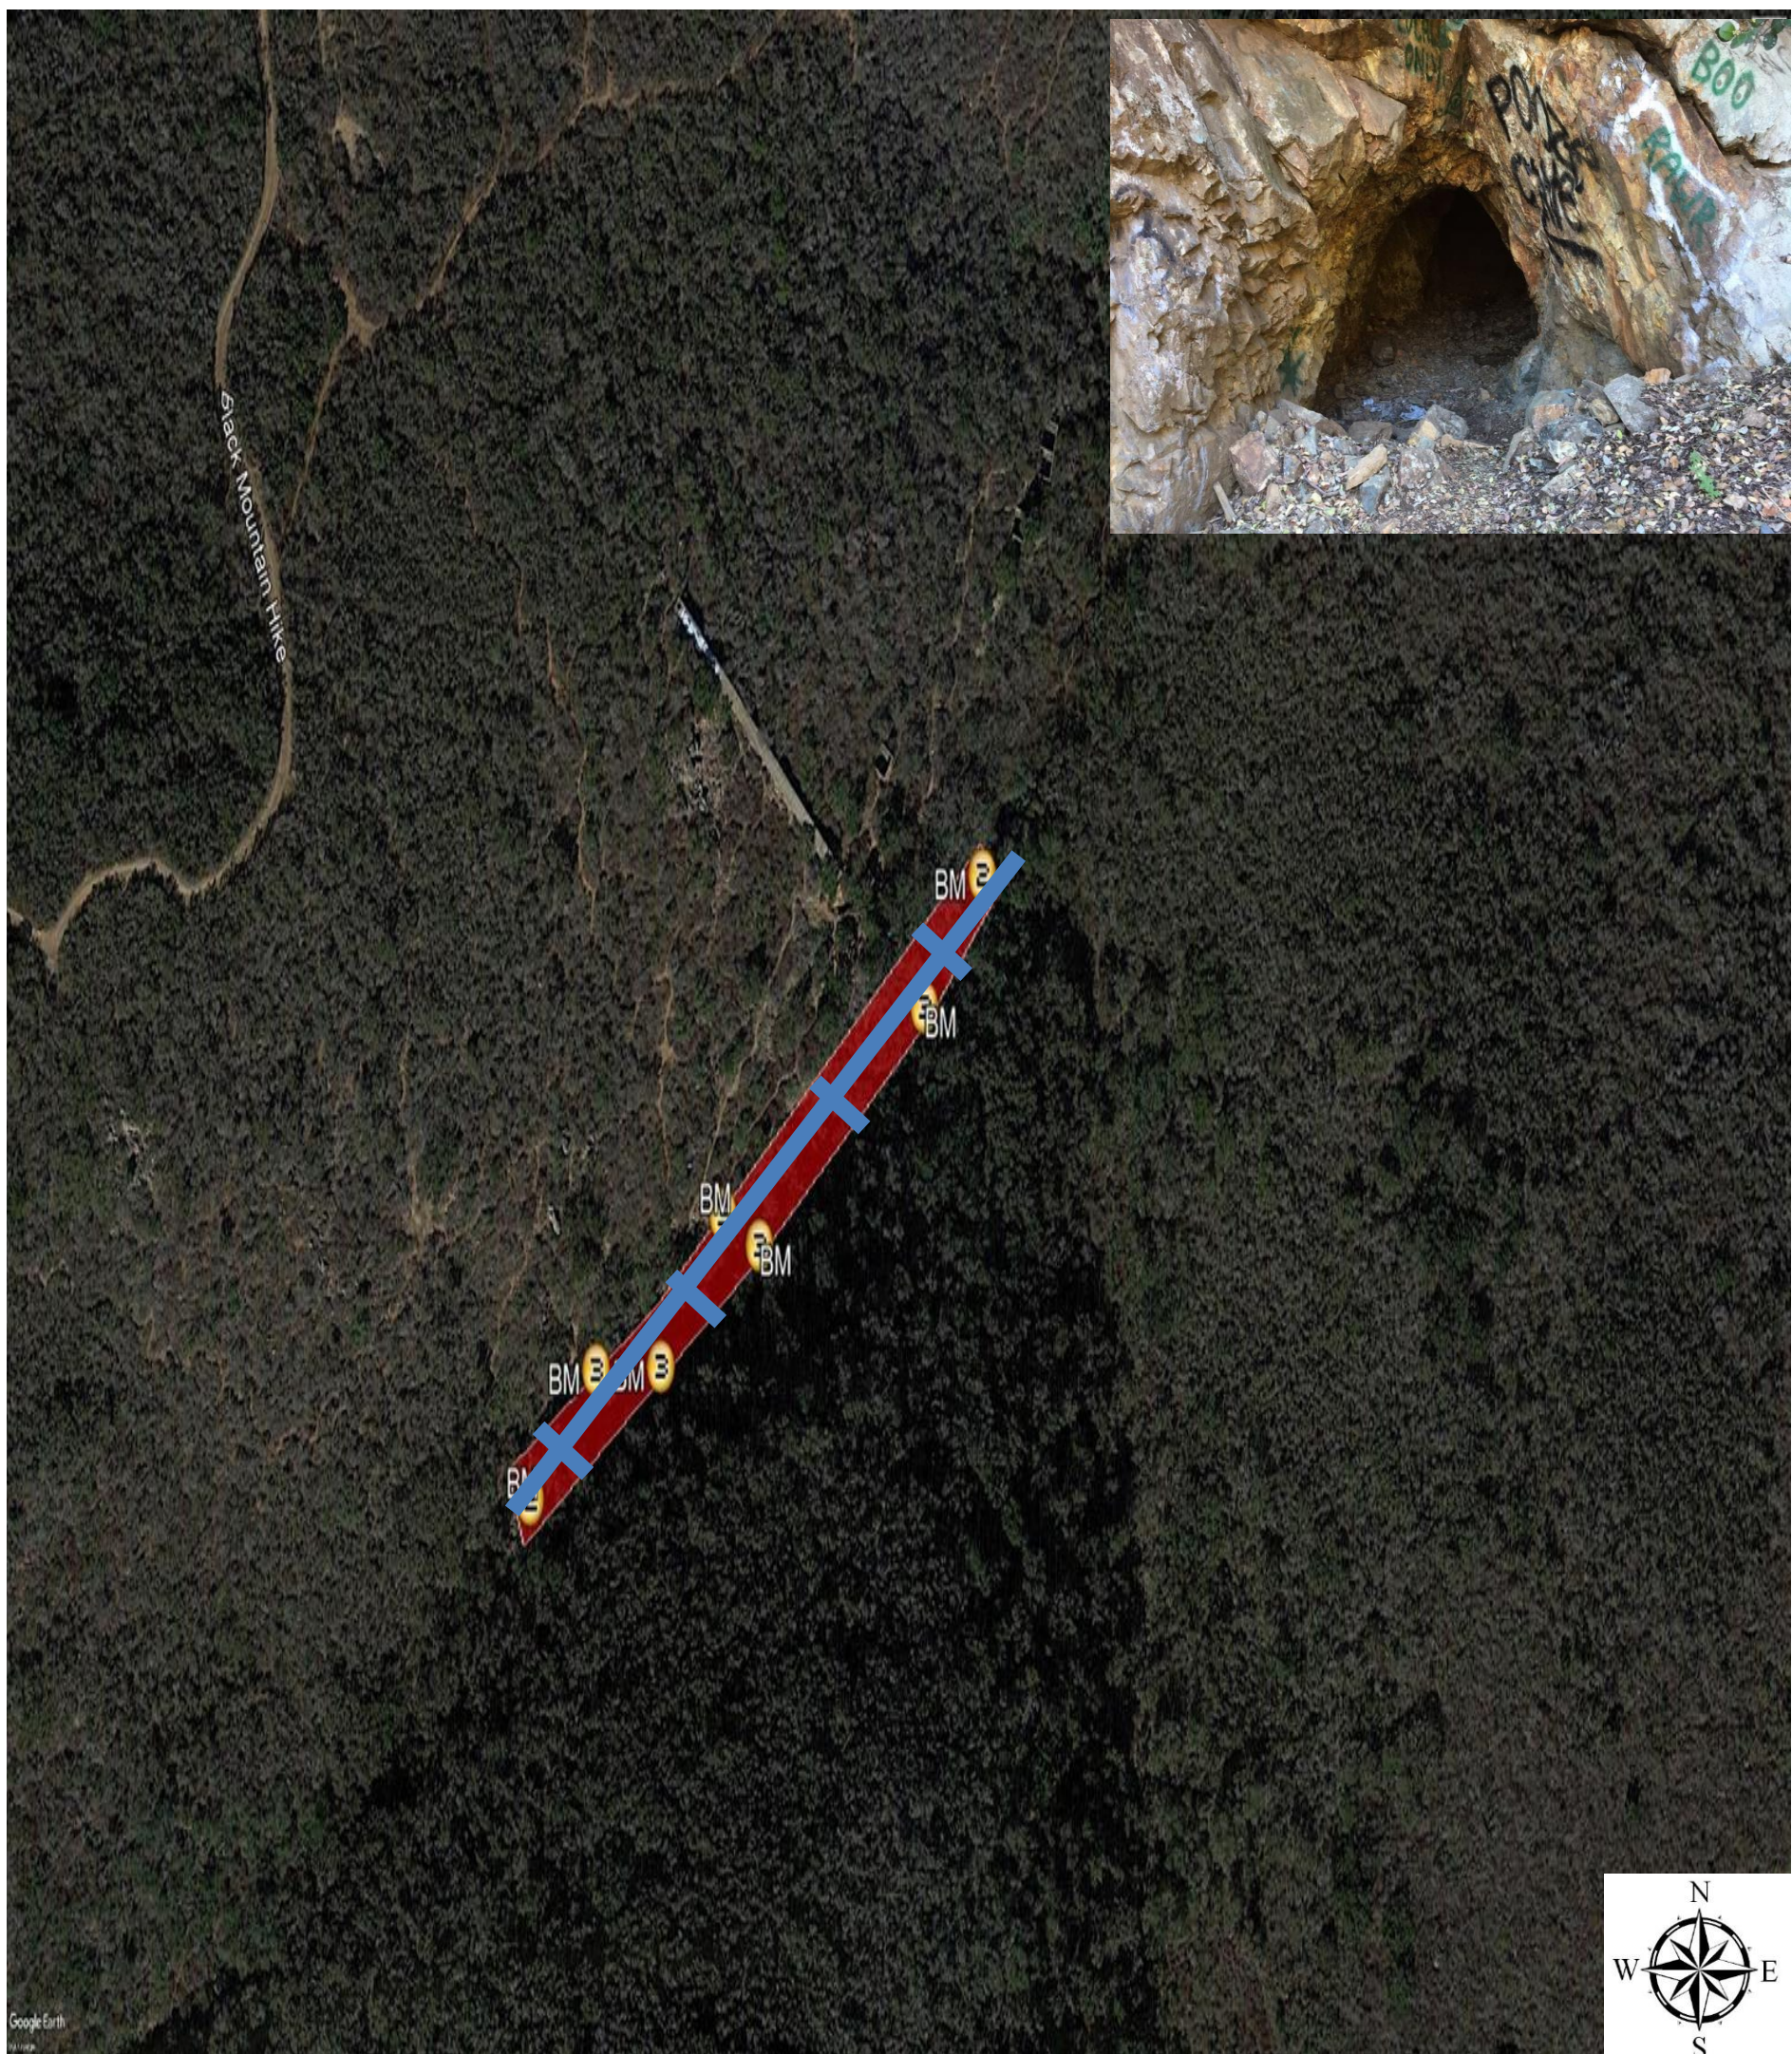
Figure 4: Waste rock surface area and GPS shots for the Koala and Hobbit deposits. Inset is picture of Koala mine adit. Proposed seismic transects in blue.
